Restoration of St Giles' Church

A summary for the Stoke Poges News

By Simon McDowell, restoration project manager & churchwarden

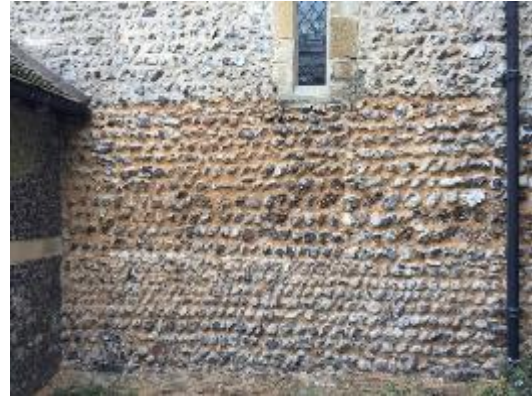
The major item here was a full rendering (covering in plaster) of the Chancel North Wall. This is how it would have been originally covered, but tastes change it was removed several hundred years ago. We only did the largely-unseen North wall so the iconic view of the church remains the same. The wall, which contained a lot of cement, was raked out.

Then the render was applied in successive layers, until it was 2-3 inches (50-75 mm) deep. The wall has now begun to weather and will soon look as if it has always been there.

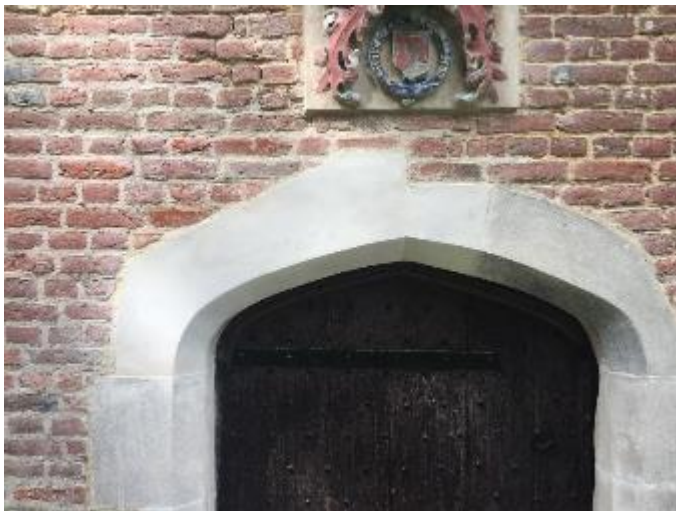
If you visit St Giles' do look at this door and see if you can spot the new pieces of oak patched into the 450-year-old door. There are 3 pieces – can you see them all?

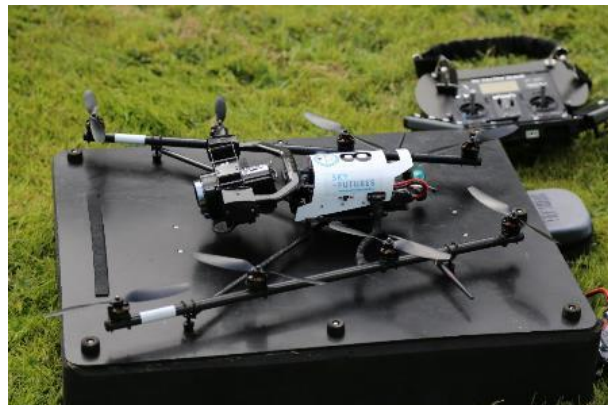
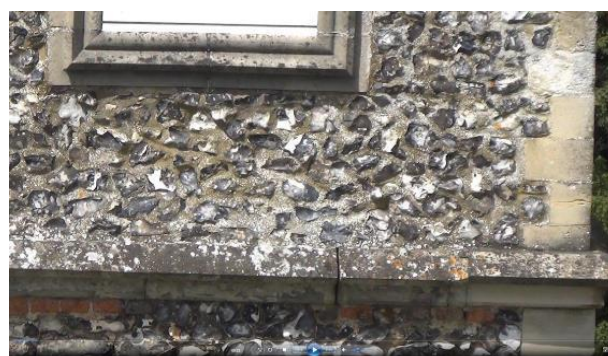
Sky-Futures, who use drones to carry out industrial inspections, filmed the Tower using their powerful camera to allow a zoom right into the detail. This allowed our architect to determine that the repairs were unnecessary.

This shows the detail that the camera obtained – only one or two small cracks in the mortar between the stones and the cornices were bedded into the wall. Might a drone be used to repair the Tower in 50 years' time?

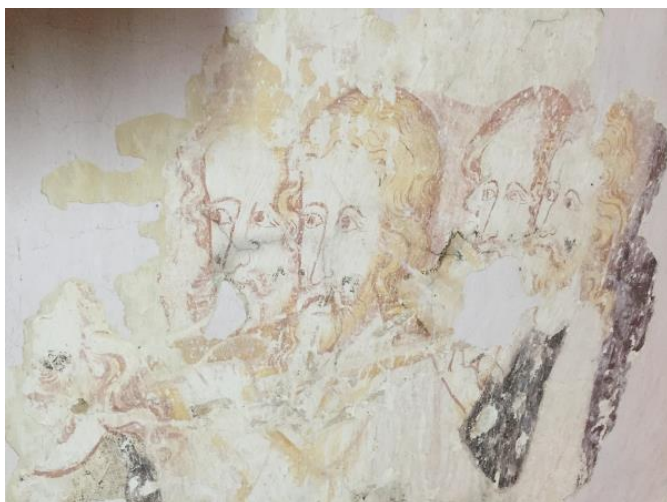
We were called over to see some red lines on the west wall of the Tower. "Interesting, but not that important", we thought and continued our review.

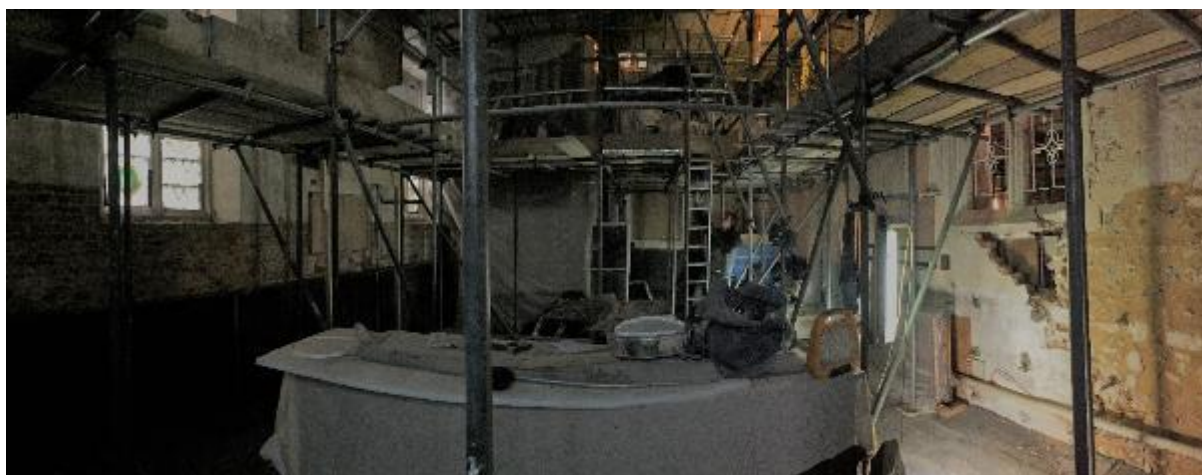
This was the easier part of the work in the Hastings Chapel. The picture above, looking West during the works, shows the plaster scraped off the walls on both sides and partly replaced on the right-hand side.

Also visible are the repairs we did beneath the window to the Chancel, as we discovered loose brickwork and had to partly remove the wall before rebuilding it to support the window lintel properly.

We found evidence of a previous repair – a rusting iron grille and a piece of oak panelling within the wall, but it is unclear whether these were from the 1947 restoration or earlier.

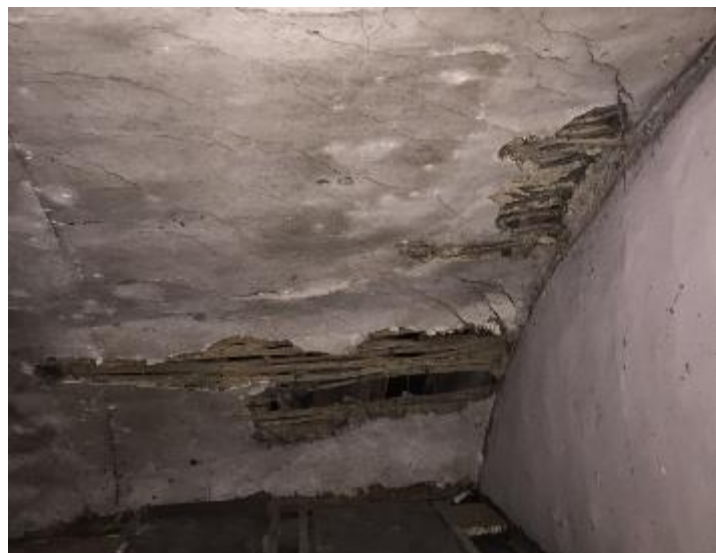
Opening up the ceiling, for possibly the first time in 400 years, was a messy process – there was centuries' worth of dirt, pieces of tile, plaster and wood piled in the ceiling. Cliveden removed dozens of sacks full of rubble.

The news was not good: we found that the massive oak beams running the full length on both sides of the roof were both rotten at one end.

Worse, we found holes in the roof supporting timbers, both in the Hastings Chapel and the Chancel, requiring further specialist advice.

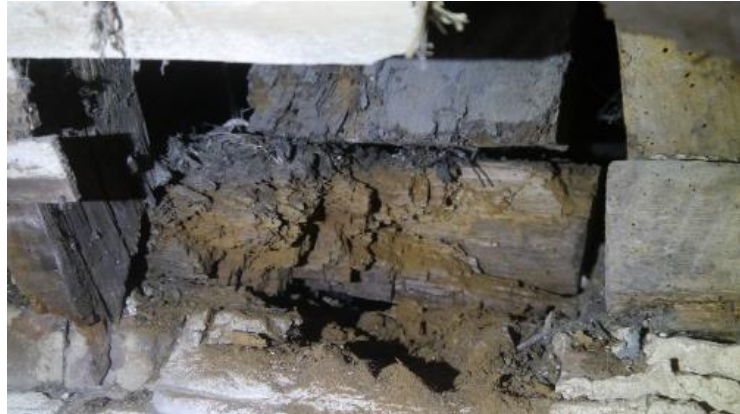
Environmental Building Consultants Ltd found woodworm and Death Watch Beetle had been present, but importantly, moisture content in the wood at 12-15%, was too low for a current infestation. We have the tiled roof replacement of 1968-9 to thank for that.

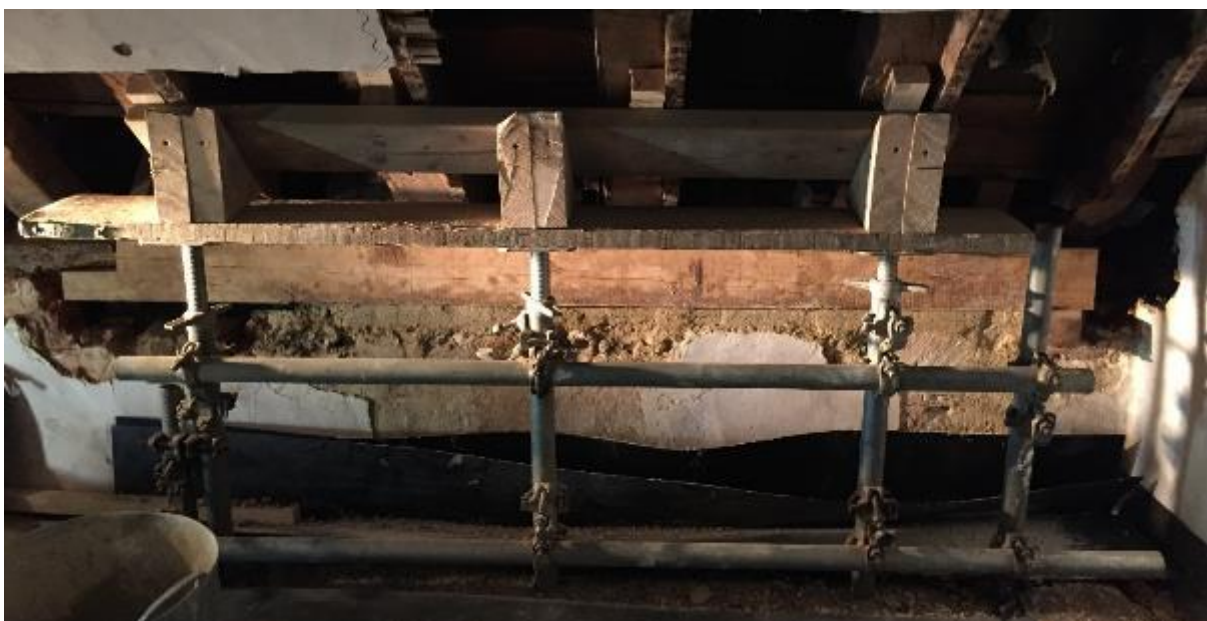
The southern end, visible externally – it is a tight fit. Here, the shorter Northern section has been added and jointed to the remainder of the existing plate.

The roof repair plan included: 4 metres of oak wall plate in two sections and weighing 750 kg in total, to be lifted into place, whilst supporting the roof to allow the replacement to be fitted.

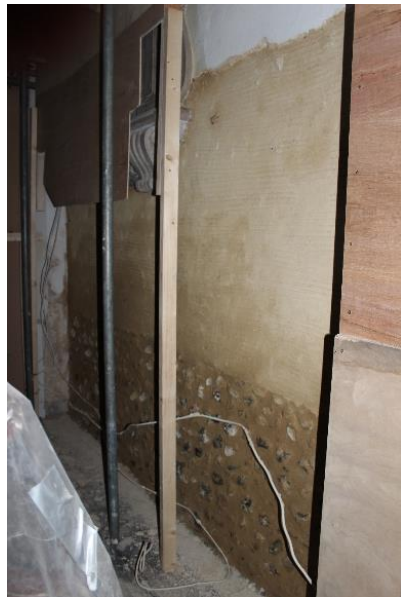
In this photo, from the North wall, the untouched white wall can be seen at the top, the middle section is freshly re-plastered and the bottom, normally hidden behind the choir pew, has been scraped out and re-pointed.

Similar work was done on the East wall around the altar and the de Molyns monument, or Easter Sepulchre (seen behind the boarding on the extreme right of this photo) was repaired.
