Restoration of St Giles' Church

A summary for the Stoke Poges News

By Simon McDowell, restoration project manager & churchwarden

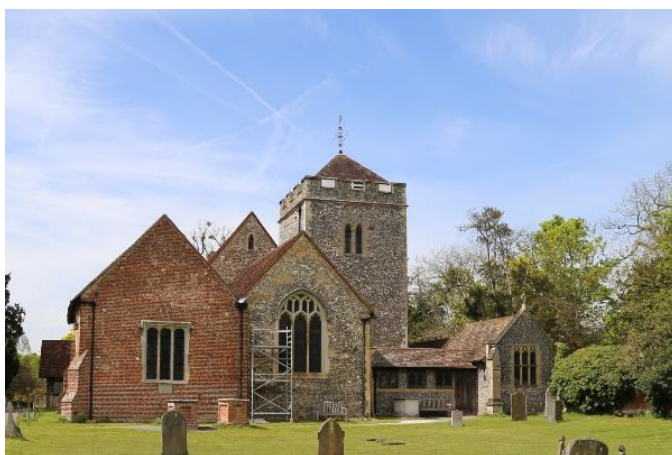
This photo, taken during the works, shows the church today. From left to right: the Hastings Chapel (1558), Nave (behind the Chancel), Chancel, Tower (all around 1230) and Vestry (1907).

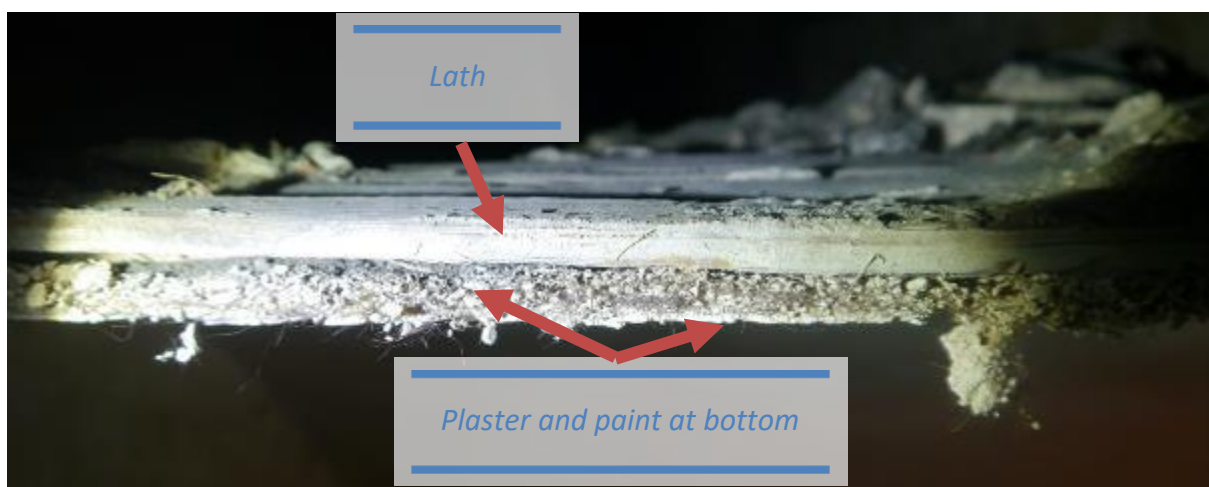
The ceiling in both the Hastings Chapel and the Chancel is of the same construction, despite the 300 years separating them. The ceilings are made of thin wood laths covered in plaster, forced between the laths to form 'nibs' to hold the plaster on – this is a cross-section:

On removing the board, we discovered the ceiling condition might be worse than feared.
